Assessment of a fire-damaged concrete overpass: the Verona bus crash case study

Verona bus
crash and fire

Roberto Felicetti

Civil and Environmental Engineering, Politecnico di Milano, Milan, Italy

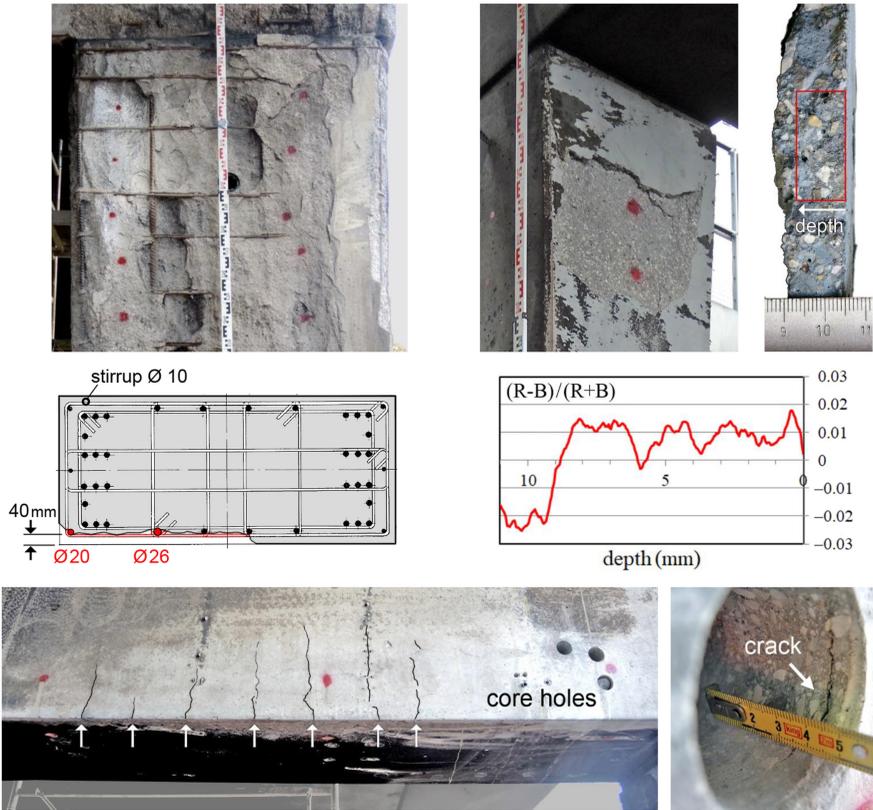
As concerns fire, the visible signs of damage include spalling on one side of the impacted pillar (with direct exposure of some rebars) and diffuse surface cracking and cover delamination of the above transverse beam.

The visible damages observed during preliminary inspection (Figure 2) include spalling on the upper half of Pillar 1, with direct exposure of two longitudinal rebars and some stirrups (then, a small share of the member reinforcement). A stable delamination of large plates (10–15 mm thick) was recognized at the top of Pillar 2. Here the fractured debris could be easily removed and inspected for discolouration. Extensive incipient delamination was detected by hammer tapping also at the intrados of the transverse beam, together with regularly spaced vertical cracks with the same pitch as the stirrups. In summary, no lack of rebar protection affected these latter two elements.

Figure 2. Observed damage patterns: spalling at the top of Pillar 1; stable delamination at the top of Pillar 2 and discoloration of a detached plate; equally spaced cracks and incipient delamination at the bottom chord of the transverse beam

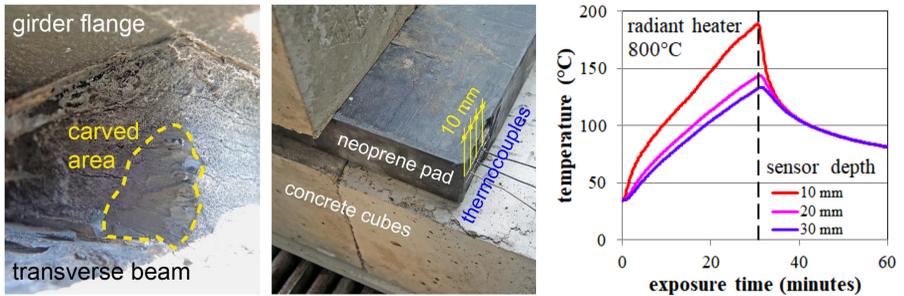
A last aspect deserving attention was the possible damage undergone by the elastomeric bearing pads laid between the transverse beam and the box girders. Visual inspection showed a charred surface on the most exposed sides (Figure 3). However, carving a thin slice was sufficient to expose an intact material with a rubbery consistency. In a laboratory test, a identical pad was stacked between concrete cubes and exposed to 30-min intense radiant heating (about 50 kW/m^2). The specimen showed limited charring depth (4 mm) and decreasing heating rate, due to the protective effect of the charred layer and the high conductivity of the reinforcing metal shims. The maximum temperature at 10-mm depth was below the onset of decomposition as indicated by thermogravimetric analysis (Caballero *et al.*, 2005), confirming the good fire endurance of this component.

Figure 3. Charred skin removal from a neoprene bearing pad and heating curves resulting from the radiant heater test

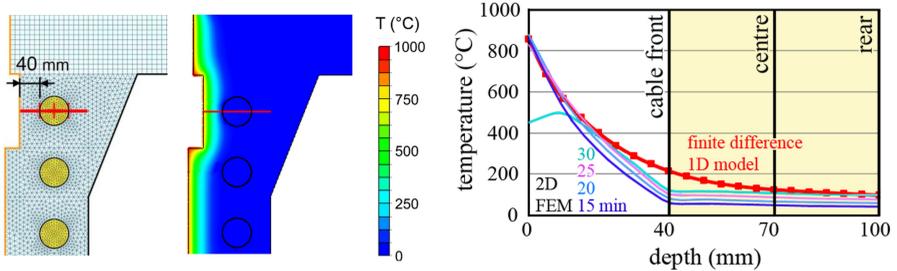
Figure 6. FE model of the recess region of the girder and maximum temperature envelope profiles in the cable and its cover

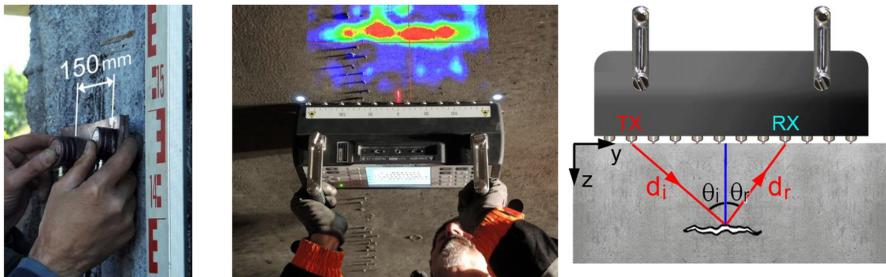
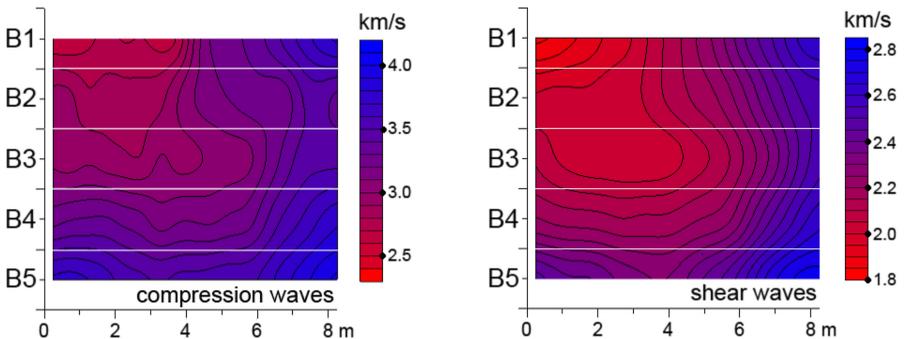
Figure 7. Setup for fast UPV mapping via the indirect method and the A1040 MIRA tomograph; their respective pulse velocity maps detected at the intrados of the five box girders composing the deck (abscissa measured from the portal edge)

This setup was used to scan the central axis of the girders flange (0.5 m step) and several vertical alignments along the pillars (0.25 m step) and horizontal sections along the transverse beam (0.5 m step). The results pertaining to the deck intrados were collected in the form of a map (Figure 7), clearly illustrating the remarkable pulse velocity reduction in the area right above the burnt coach. Damage tends to vanish at a distance exceeding 8 m from the portal edge and in the farthest beam. It has to be stressed that the minimum indicated values represent the mean pulse velocity along a curved ray path plunging to about 20 mm in the damaged cover (see the wavefront trajectories in Figure 10).

Besides the different magnitude (shear waves are 40% slower than compression waves), the resulting map (Figure 7) is very similar to the one obtained by means of the traditional UPV method. However, merging 66 waveforms in one measurement allows offsetting the local disturbance due to cracks, rebars and other defects, producing a smoother output. To be mentioned is that both mapping techniques were implemented at the pace of 25 test points per hour, minimizing the traffic disruption in this strategic highway.

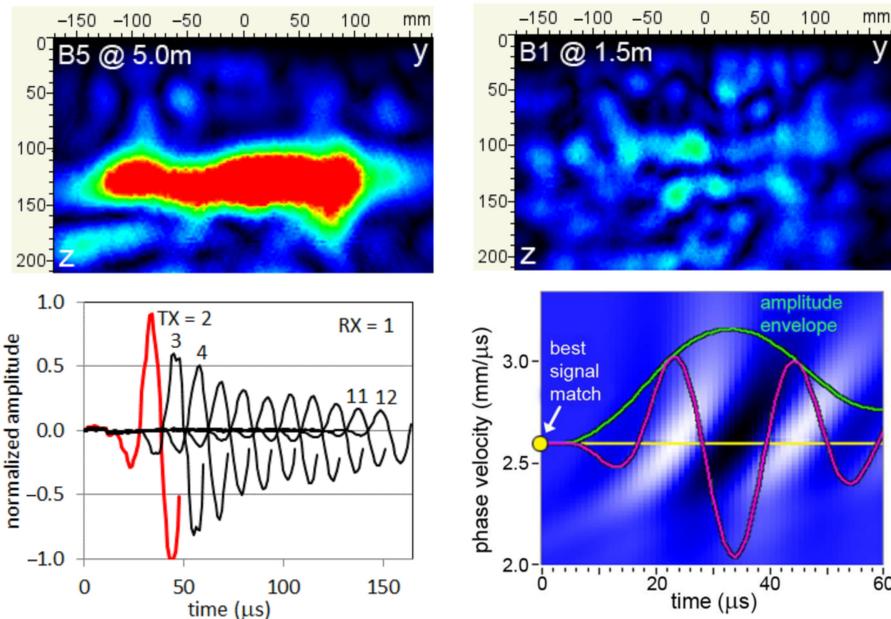
In the application at issue, the steep gradients of pulse velocity tend to invalidate the SAFT algorithm and the strong bottom-echo produced by the inner cavity of the girders progressively vanishes as fire damage increases (Figure 8). Nonetheless, the slower surface layer tends to

Figure 8. Different strength of the bottom-echo in case of pristine and damaged concrete flanges, regular increase of arrival time at the increasing transmitter–receiver distance, assessment of surface wave velocity by optimization of the pulse alignment

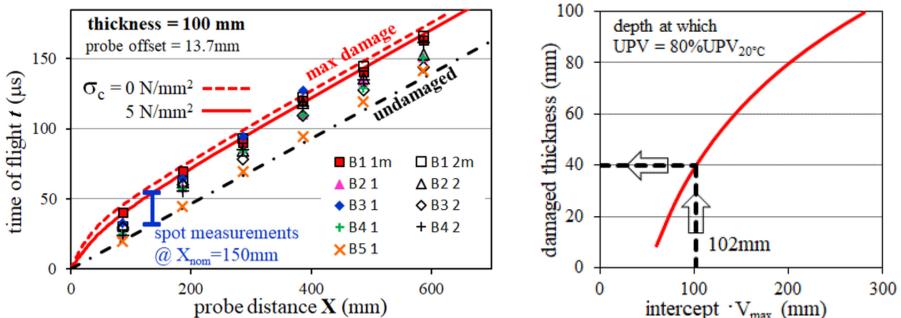
In situ measurements were taken along the central axis of each box girder, at a 1 and 2 m distance from the edge of the supporting transverse beam. The comparison against the theoretical trends (Figure 11) shows that all results lie between the plots pertaining to undamaged concrete (a straight line of slope $1/V_{20^\circ\text{C}}$) and to the maximum expected damage above the localized fire source. A good correspondence is observed between damage depth and the location in the general velocity maps of Figure 7, with smoothly decreasing effects in Beams 4 and 5. The effectiveness of spot measurements at $X = 150$ mm nominal probe distance in discriminating damage levels in this range is also highlighted in the diagram.

It has to be remarked that the theory of waves refraction allows establishing a direct connection between velocity profiles (and then mechanical damage) and field results. This is the basis behind the semi-empirical correlation proposed in Felicetti (2013), providing an indication of the damaged thickness, with no specific assumptions on the fire scenario and the inherent material sensitivity to fire. However, the limited thickness of the flanges under study would require to adapt the proposed relation, since the depth at which a 20% decay of pulse velocity is assigned ($T = 300^\circ\text{C}$, depth ≈ 30 mm in Figure 9) is overestimated by about 10 mm.

Figure 11. Comparison between measured pulse propagation times and the theoretical $X-t$ curve descending from the assumed fire scenario; quick assessment of damage depth according to the semi-empirical correlation proposed in Felicetti (2013)

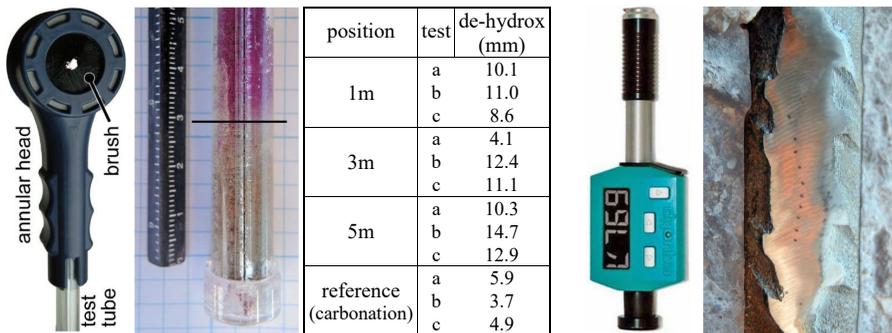
De-hydroxylation depth. Calcium hydroxide is the main source of alkalinity in concrete pores. It is decomposed by heating above 450 °C, leading to the formation of calcium oxide, which is a highly hygroscopic product. For this reason, the reaction is reversible and can be recognized only if no water is used while sampling, as is made possible by collecting drilling powder via the Carbontest[®] kit (Felicetti, 2013). Tests performed on the portal confirmed the lower impact of fire, as anticipated by colour analysis (max de-hydroxylation depth = 10.5 mm). Checks on the exposed web of the first girder (Figure 12) gave slightly lower values than expected (<15 mm vs 16.8 mm in Figure 9), confirming the assumed fire scenario as a cautious description of the event.

Dynamic hardness tests on rebars. Steel rebars may recover a significant share of their initial strength during cooling, though this strongly depends on their metallurgical features (alloying elements, thermal and mechanical working process – Felicetti *et al.*, 2009). The dynamic hardness test (Leeb method) is a viable tool to assess their residual performance regardless of original quality (Felicetti, 2014). Tests were performed on one rebar exposed by spalling in Pillar 1 and a reference piece uncovered by chiselling on the opposite side. The results (mean rebound index/std deviation = 515/6 and 536/8, respectively) showed a marginal decay of the rebar response (−4%), which corresponds to an almost double loss of yield strength. Given also the minor contribution to the sectional capacity of rebars laid bare by spalling (Figure 2), this confirms the little impact of fire on this element. For Tempcore bars, a permanent loss of strength of about 10% can be ascribed to heating in the range between 600 and 700 °C (Felicetti *et al.*, 2009), which seems coherent with the other observations.

Figure 12. The Carbontest[®] kit, a de-hydroxylated powder sample (scale factor 2.25) and results collected on the exposed web of the first girder; Leeb dynamic hardness tester and resulting indentations on the smoothed face of an exposed rebar of Pillar 1

Reference measurements were also performed on elements not impacted by fire in order to determine the original carbonation depth (about 5 mm, corresponding to the minimum detectable dehydroxylation depth), and the values of compression- and shear-waves velocity in undamaged box girders (4.4 and 2.8 km/s, respectively).

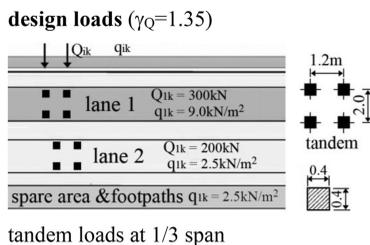
Concerning the ultimate capacity of the critical section, the performed investigations led to the conclusion that the post-tensioning cables underwent a non-significant heating (<120 °C, Figure 6), whereas temperature exceeded 300 °C in the first 30 mm of the most exposed cover (temperature profile of Figure 9). Though concrete is expected to retain most of its strength at this reference temperature, stability in the presence of possible fractures and durability in case of increased porosity were also of concern. Then, a check on the residual capacity was performed by neglecting any contribution from this layer. The results showed that the original extra capacity in the hogging bending moment region dropped from +30% to +10% relative to the design bending moment as per the current design regulations (Figure 13). Even though the safety check was passed, the sizeable loss of resisting area caused a rise of the neutral axis at the Ultimate Limit State from 20% to 35% of the cross-section depth, significantly affecting the rotation capacity of the weakest cross-section in this redundant scheme. Some strengthening works were then recommended to the highway management to reinstate the original sectional ductility as well as cover stability.

Figure 13.
Design loads and diagrams of the design and resistant bending moments for the most fire-damaged girders

The original design of the bridge dates back to the early 1980s when military loads were still considered by the Italian design code. This resulted in a slightly more demanding design hogging moment compared to the current regulations, entailing somewhat oversized cross-sections. As a first step, the profile of post-tensioning cables was digitized in a spreadsheet file and the effect of equivalent tendon loads was introduced in the elastic model of the redundant static scheme of the girder (assumed final/initial tendon stress = 90%, fiction coefficient = 0.2). The results confirmed a negligible effect of post-tensioning on supports, validating the concordant profile of cables. Moreover, the elastic analysis under dead loads allowed assessing the compressive stress borne by the bottom flange during fire (≈ 5 MPa), which mitigates the thermal damage (Figure 9) and fosters the sensitivity to spalling (Lo Monte and Felicetti, 2017). The model was also used to determine the maximum reaction force (≈ 300 kN) which would be possible to exert with a temporary support at midspan in order to unload the same flange during repair works.
