A computer vision approach to improve maintenance automation for thermal power plants lubrication systems

Nengsheng Bao, Yuchen Fan and Chaoping Li

Abstract

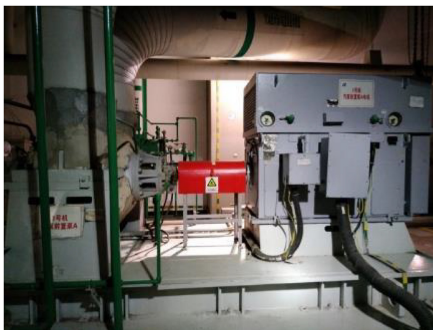
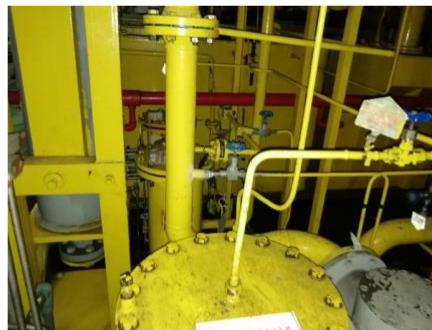
Figure 1.
TPP complex
environment: (a) front
pump; (b) oil station

complexity of the actual environment (see [Figure 1](#)) and the limitations of the state-of-the-art methods, the existing oil leakage methods cannot be directly used in TPPs environments for maintenance automation purposes.

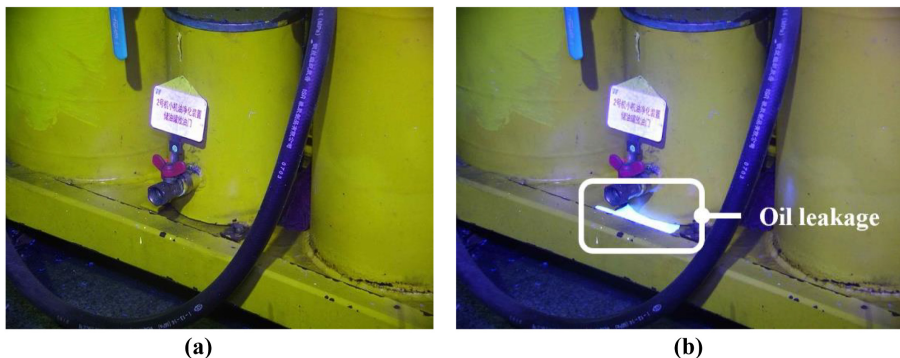
Figure 2.
Oil leakage under various sources of light: (a) visible light; (b) UV light

When the UV light source is used to illuminate the area to be inspected, a blue-white fluorescence occurs on the oil leakage surface, as shown in Figure 2. This kind of light source, within a poorly illuminated indoor context, allows to highlight the oil leakage for a facilitated detection.

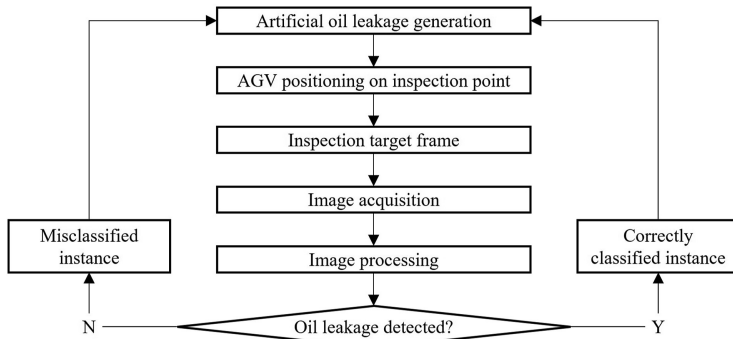
Figure 14.
Flowchart of the experimental process

Figure 14 illustrates the experimental procedure. A number of artificially simulated oil leakages were randomly placed along the 13 inspection points throughout the testing area (see Figure 13).
