Wheel/rail-force-based maintenance interval extension of the C80 series wagon

Qi Xiao, Weidong Yu, Guangrong Tian and Fangxuan Li
*China Academy of Railway Sciences Corporation Limited,
Locomotive and Car Research Institute, Beijing, China*

Purpose – This study aims to introduce the achievements and benefits of applying wheel/rail-force-based maintenance interval extension of the C80 series wagon in China.

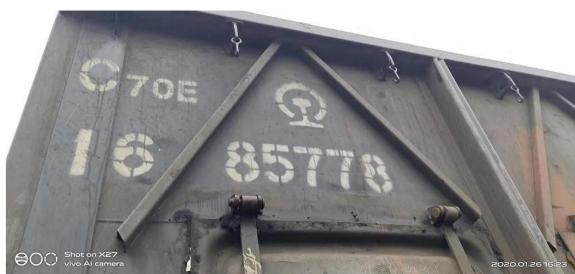
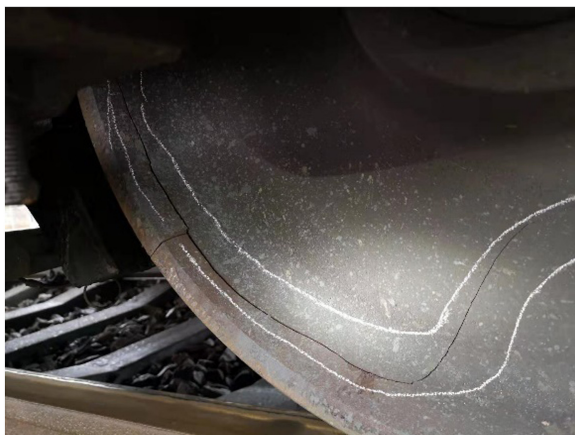
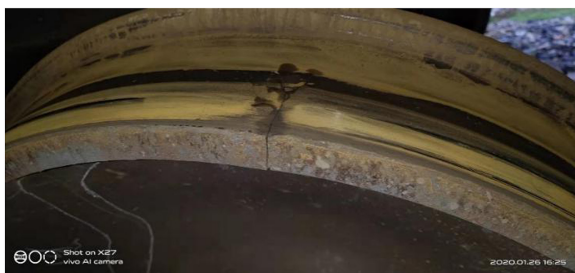
a circumferential crack of 468 mm

a rim crack of 28 mm

Figure 6.
Shattered rim of C70E
1685778

In January 2020, the wheels of a C70E wagon triggered two consecutive damage alarms when passing through the TPDS detection station (Table 1). After inspection by the operation workshop, it was found that the wheel had a circumferential crack of 468 mm, a radial crack of 310 mm and a rim crack of 28 mm (Figure 6). The car was immediately detained to prevent a possible wheel failure. Therefore, using TPDS, we can timely detect rim crack failures and prevent wheel collapse from causing train derailment.

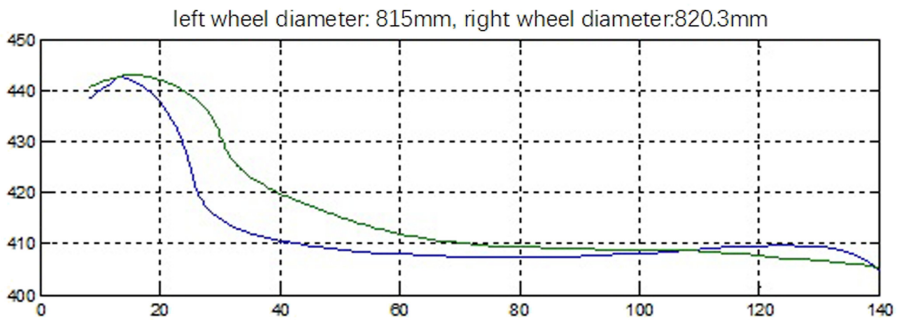
Figure 10.
The tread profiles of C80_{BH} 4390230 first axle

Figure 10 shows the measured comparison results of the tread profiles of the left and right wheels of the first axle of the C80_{BH}4390230. It can be seen that the tread wear of the left and right wheels of the car is very different.
