Examining approaches to investigating the United Kingdom's existing building fabric in the pursuit of net zero targets

Paper type Case study

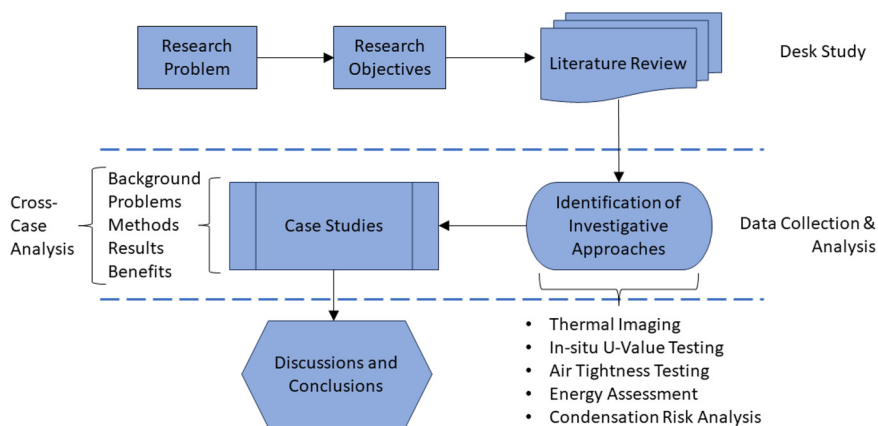
Figure 1. Schematic presentation of research design

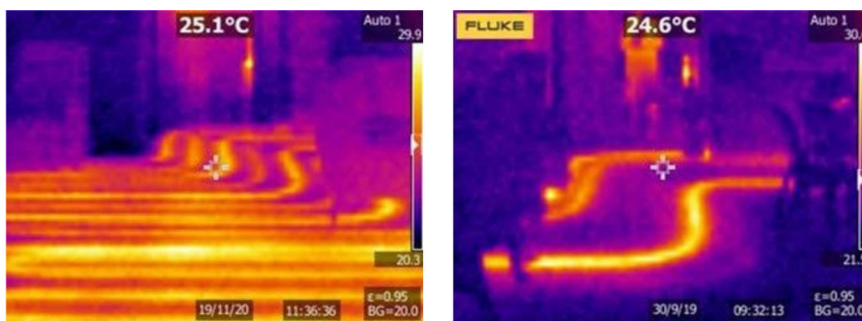
Figure 2. The underfloor heating is shown before and after the thermal imaging photograph of the retrofit

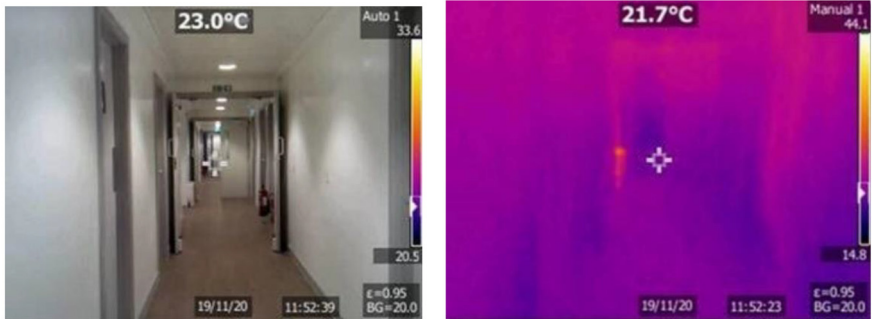
Figure 3.
Is the first in the two-story portion, where the temperature is spread equally

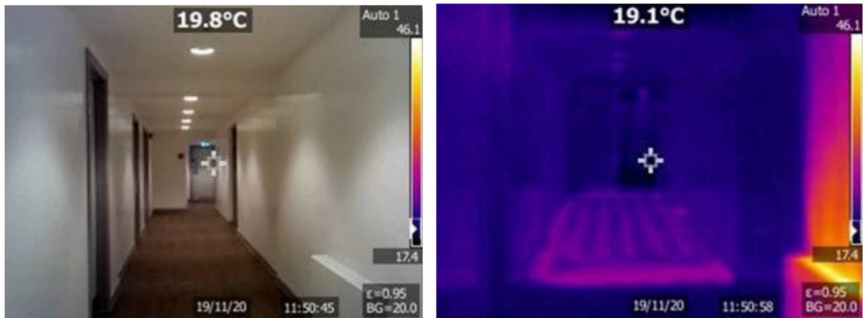
Figure 4.
The single-story section (with the original loft insulation) shows the underfloor heating pipes, a wall-mounted radiator and the corridor's actual temperature

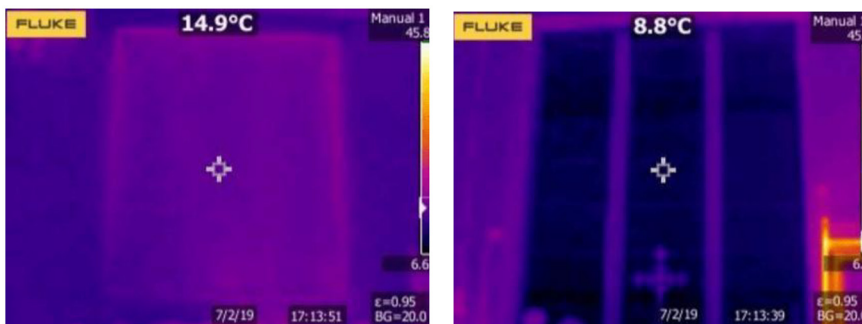
Figure 5. Photo taken from inside the church with the blinds closed (left) and Photo taken from inside the church with the blinds open (note, heating pipe on the right – yellow) (right)

Findings: There was a substantial decrease in heat loss when window blinds were closed. Also, closed curtains and blinds could exhibit similar effects during double-glazing. Findings also revealed that the roof was properly insulated. Also, thermal imaging of the door shows that the seals need replacement as they allow seepage of cool air into the building. Also, although the windows were double-glazed, which is very effective, window

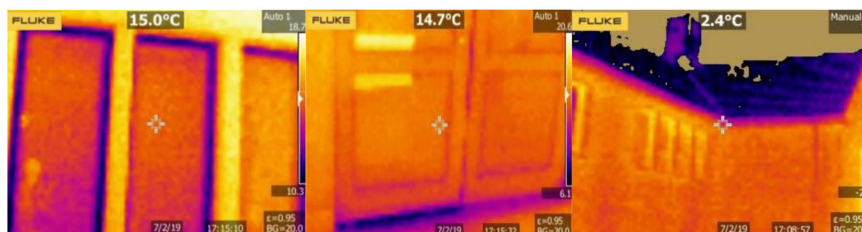
Notes: A photo of the main doors taken from within the church shows that the seal on the bottom of the door has to be replaced (middle), and the Church roof is taken from outside – the blue roof shows that the church roof is well insulated

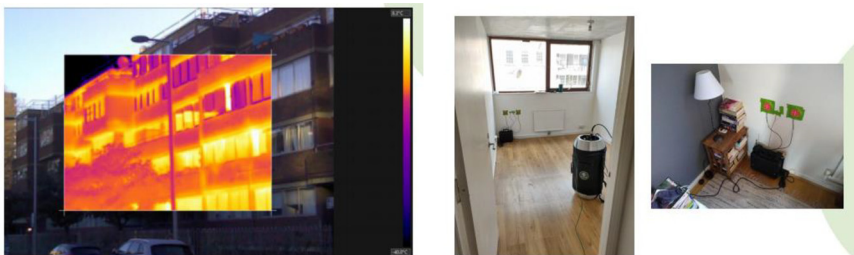
Figure 7. Use of External thermography to highlight areas of particularly high heat loss (left) and Heat3D and the U-value Measurement System were used to measure U-values to understand the current condition of the walls, floors and ceilings and to provide information for the specification of extra insulation (right)

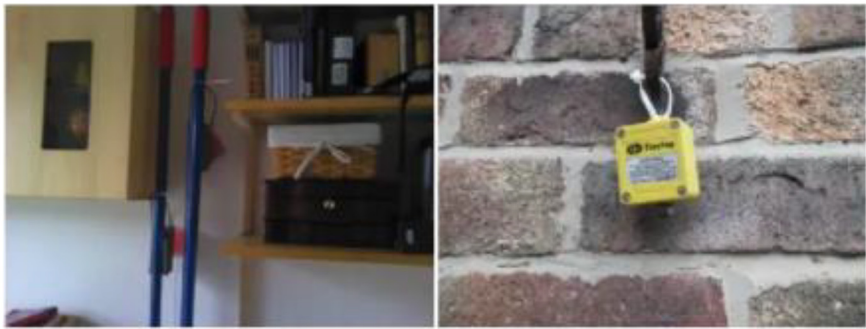
Figure 8.
The apparatus set up in an occupied home (left-hand image), with clamps and teleports (blue poles) supporting the heat flux plates (red discs) and indoor temperature sensors

Note: A tiny tag datalogger (right-hand image) is also displayed and mounted to an exterior wall (out of direct sunlight)

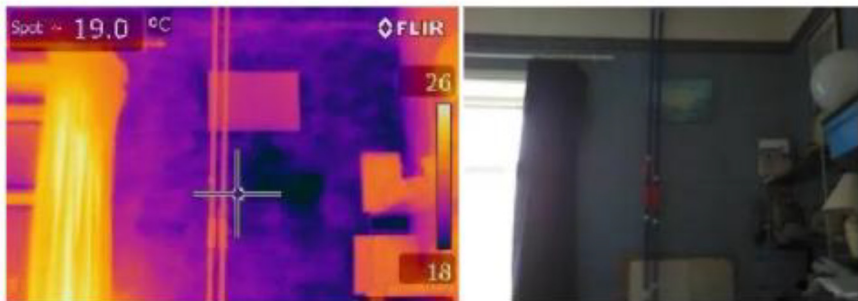
Figure 9.
A thermal image of the apparatus mounted on a wall in a building

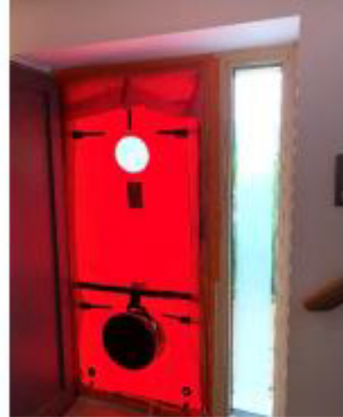
Figure 11.
(L-R) Complete 40 L pulse set-up used in this configuration for all text cases; blower door fan mounted and sealed in a panel cut to the size of the window opening

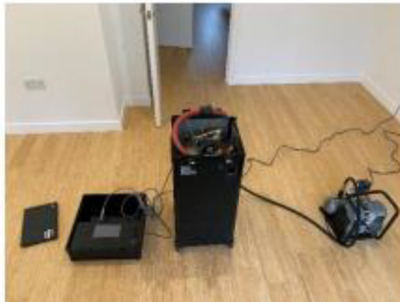
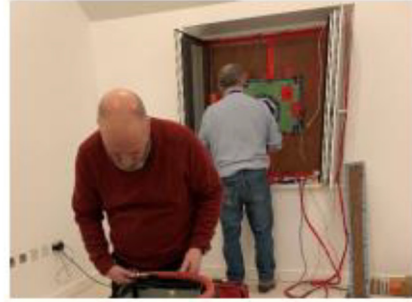
Figure 12.
Pulse and blower door fan testing in a small 94 m³ art studio

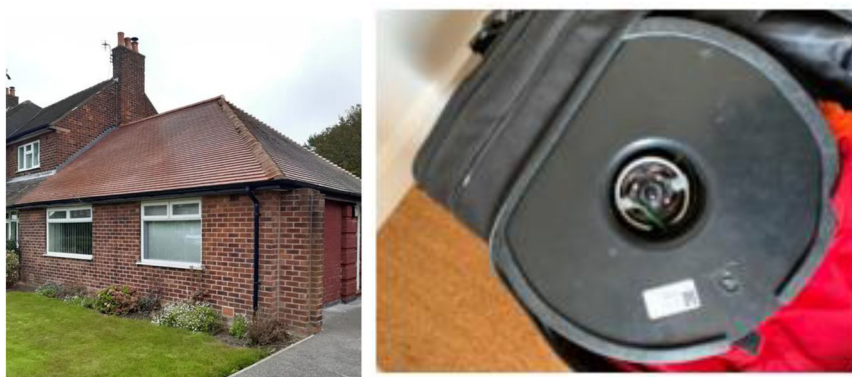
Figure 13.
(L-R) retrofitted building: a very low min fan is required for the fan tests, with a large restrictor plate fitted

Findings: The overall air permeability of the house before the retrofit was 1.69 ACH@4Pa (1/h). Following the refit, this figure significantly decreased to 1.15 ACH@4Pa (1/h), underscoring the importance of considering ventilation even with individual modifications. The measured air permeability of each room exceeded 1.5 ACH@4Pa (1/h), suggesting sufficient ventilation for the entire building and each specific room (Build Test Solutions, 2022).

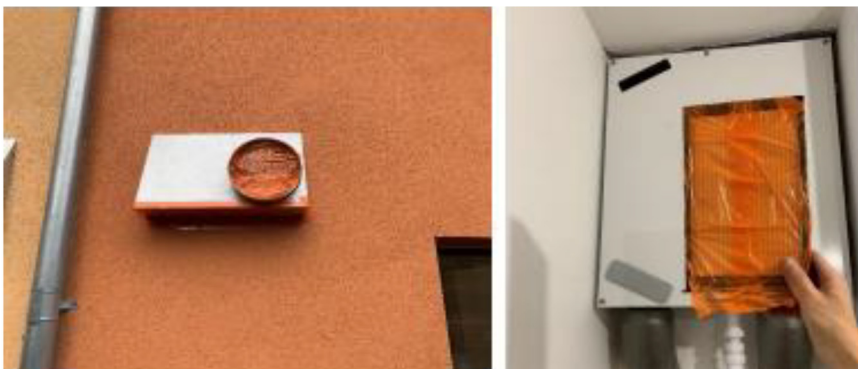
Figure 14.
MVHP units
switched off with
both inlet and
exhaust sealed
internally or
externally

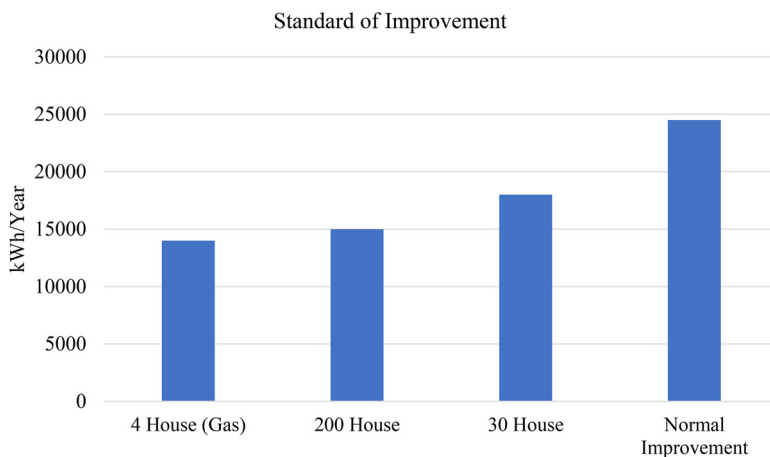
Figure 15.
Energy
characteristics of 30
House study groups

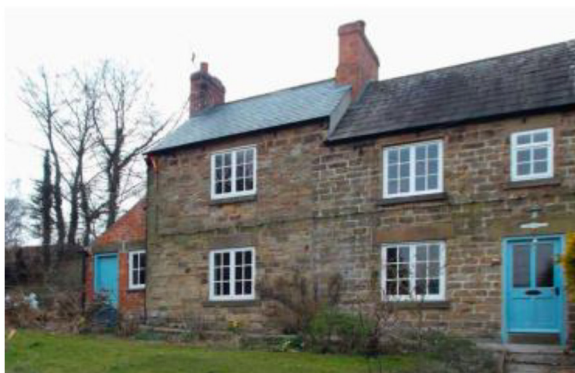
Notes: A large number of historical changes, potentially a row of cottages. The floor space is 78 m²
Source: Historic England (2022)

Figure 16.
 Rose Cottage in 2021
 (a three-bedroom semi-detached cottage from the 18th century built of coursed Hardwick stone with a brick lean-to and chimney stacks)

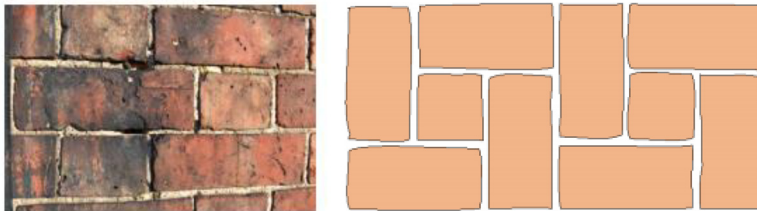
Figure 17. Bricks at Shrewsbury laid in a "brick and a half thick" Flemish bond (left) plan view showing half batts' in the centre of the wall (right)

Problem: Driven rain will collect in the open mortar joints if the wall is left as it is, so it needs to be repointed in a suitable material to shed water better. Traditional structures’ internal “common” bricks are frequently of lower quality, with less consistent shape and less frost resistance ([Figure 17](#)).

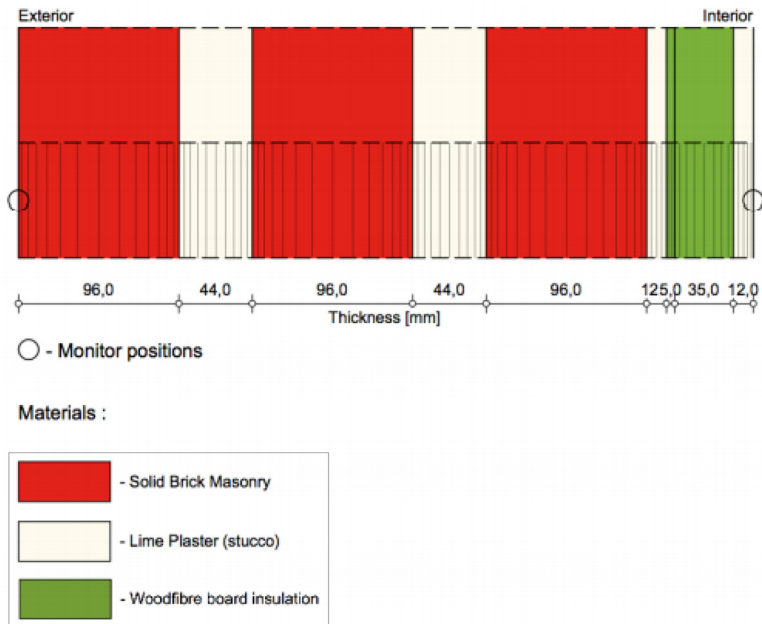
Figure 19. Post-refurbishment assignment of materials (representation of how wood fibre insulation is modelled in the simulation)

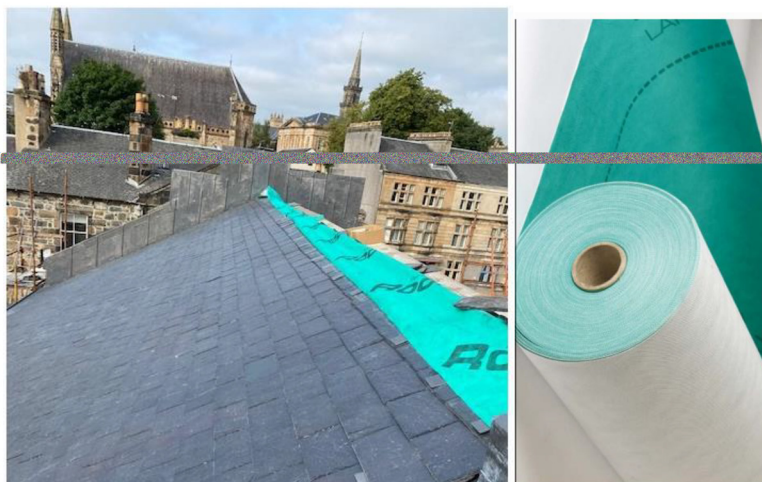
Figure 20.
Use of roofing
membrane to address
condensation risk
analysis in a historic
building located in
Paisley

Results: In Figure 20, the new roofing structure allows for high levels of airflow in addition to the transportation of moisture vapour, making the formation of condensation in the roof space practically impossible, despite the complexity of the roof structures of historic buildings and the sensitive nature of the careful consideration of moisture management and
