Assessment of a fire-damaged concrete overpass: the Verona bus crash case study

Verona bus
crash and fire

Roberto Felicetti

Civil and Environmental Engineering, Politecnico di Milano, Milan, Italy

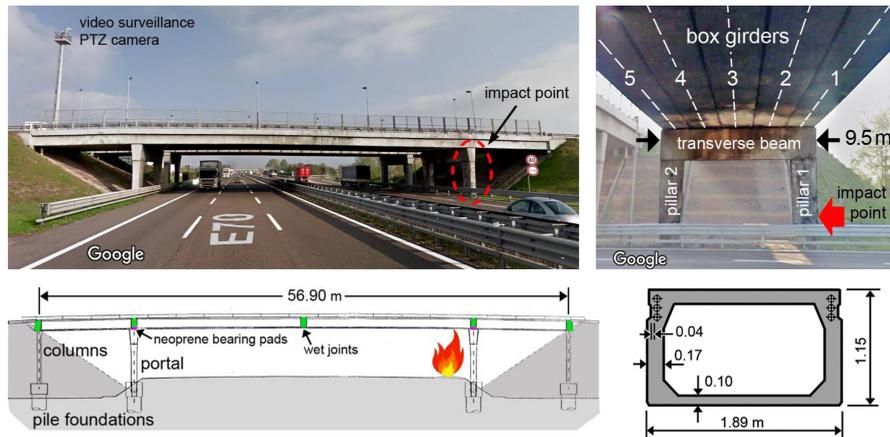
Figure 1.
General views of the
overpass under study,
elements nomenclature
and size

In all elements, fire protection of the reinforcement is provided by a rather thick cover (axis distance of stirrups = 35 mm, minimum surface distance of cables at the lateral recess = 40 mm, Figures 1 and 6).

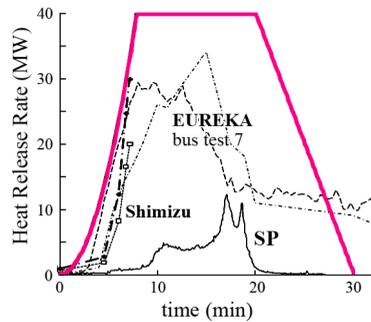
The technical specifications of the burnt coach are summarized in the table in Figure 4. The diesel fuel was contained in two tanks anterior to the front wheels, one of which was destroyed by the impact. A supplementary tank was also installed in the central part of the chassis. The surveillance camera installed across the highway (Figure 1) was not framing the accident area, but the impact instant was indicated by image blurring due to vibration of

Figure 4. Technical specifications of the coach and assumed HRR curve compared against results from the literature

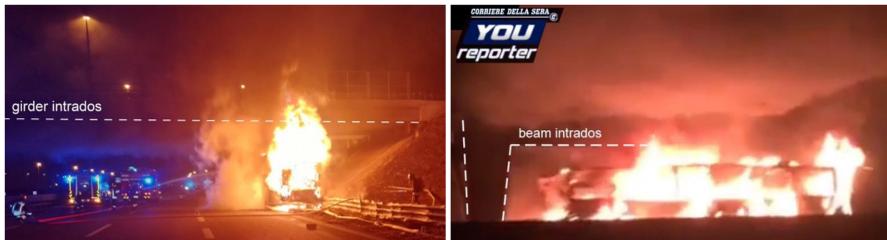
the supporting pole. Later, the camera was directed towards the vehicle, though the view was obstructed by the overpass deck. Nonetheless, it was possible to spot some smoke 3 min after the impact and long flames sticking out the parapets 1 min later. Pictures and videos shot by witnesses recorded the flame height (Figure 5). Two fire engines reached the place 16 min after the accident and flame extinction was completed about 15 min later.

The HRR curve was introduced in the Hasemi's model of localized fire (EN, 1992-1-2, 2002) with a diameter of 5 m and fire-to-soffit height of 4 m. Given the vehicle slenderness (length/width = 5.5) and the lower intensity of flames at its front (Figure 5), the assumed burning area was slightly undervalued. Due to the high thermal power, the condition where flames directly impinge the structure was met for 80% of the fire duration and the received heat flux approached the maximum value allowed by the model. This made the results insensitive to possible adjustments of the HRR curve.

Figure 5. Pictures showing the flame height in the fully developed stage of the fire

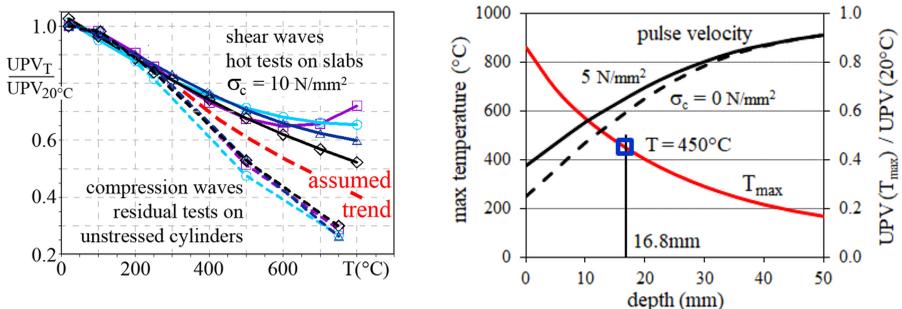
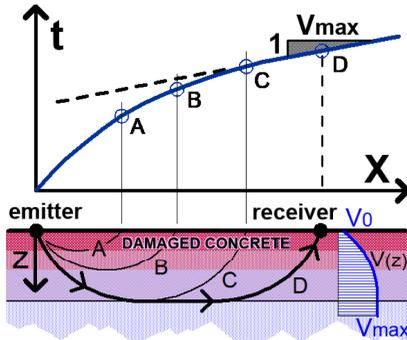
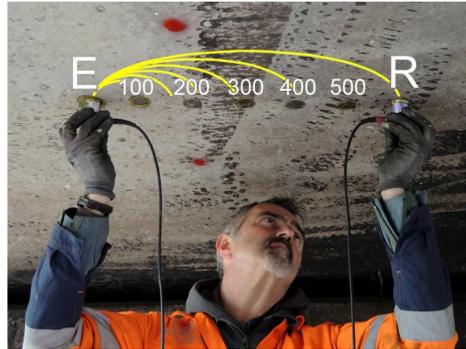
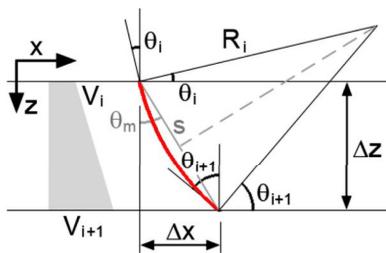
Figure 10. Basic principle of the pulse refraction method, application to the intrados of a box girder, circular ray path in a generic layer with linear velocity trend and formulas for the incremental construction of the X-t curve

To this purpose, the cover is discretized in a series of layers with linearly changing velocity through their thickness Δz (Figure 10). In each layer, a ray path obeying the Snell's law of wave refraction takes the shape of a circular arc whose radius depends on the velocity gradient (Greenhalgh and King, 1981). The increments of covered distance ΔX and time-of-flight Δt are expressed in closed form and can be summed across the explored thickness. The following hints should be considered in the implementation of this scheme:

- (1) If $V(z)$ is not monotonically increasing the formulae in Figure 10 are still valid, with $R < 0$.
- (2) A ray path of initial angle θ_0 can re-emerge if $\arcsin(V_0/V_{\max}) \leq \theta_0 \leq \pi/2$, and then $1/V_{\max} \leq p \leq 1/V_0$.
